SIDNEY & BERNE
DAVIS
ART CENTER

***Sidney & Berne Davis Art Center
Exterior Restoration Scope of Work in phases***

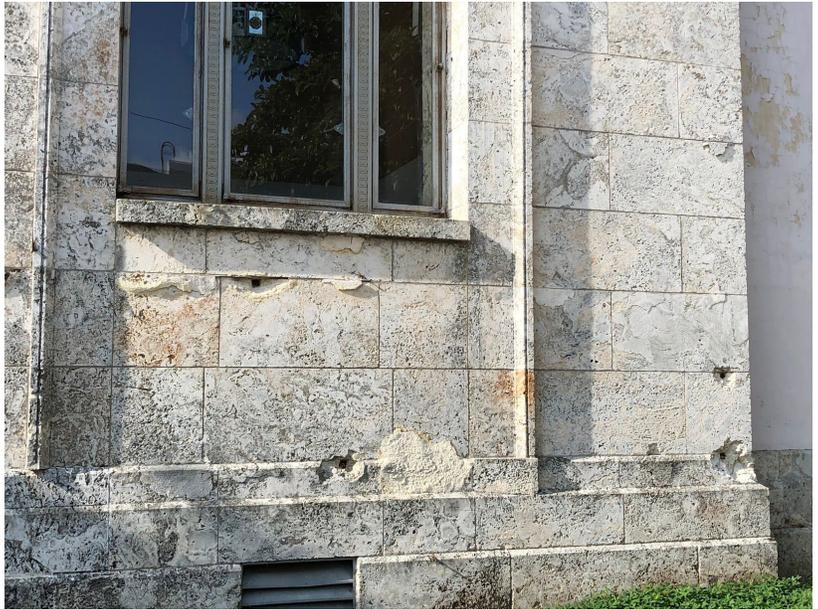
Deferred maintenance by the GSA, water infiltration, and the natural elements have damaged all exterior surfaces and walls of the original highly ornate coral limestone façade in various areas causing finishes to crumble, staining, efflorescence, and general deterioration of the exceptional Neoclassical Revival structure which is now in dire need of restoration. The roof has reached its expected useful life and the original window frames are rusted through. Total window restoration is also anticipated, which needs to meet State Historic Preservation Officer standards and requirements.

Damage and old patches to Coral Rock, Phase I

- a. Repair, preserve, and restore the original highly ornate coral limestone facade through accepted methodology provided by the State Historic Preservation officer. (\$380,000)
- b. Repair, repoint, paint, and seal all other wall materials. (\$70,000)
- c. Repair, seal, and paint decorative loggia ceiling. (\$30,000)

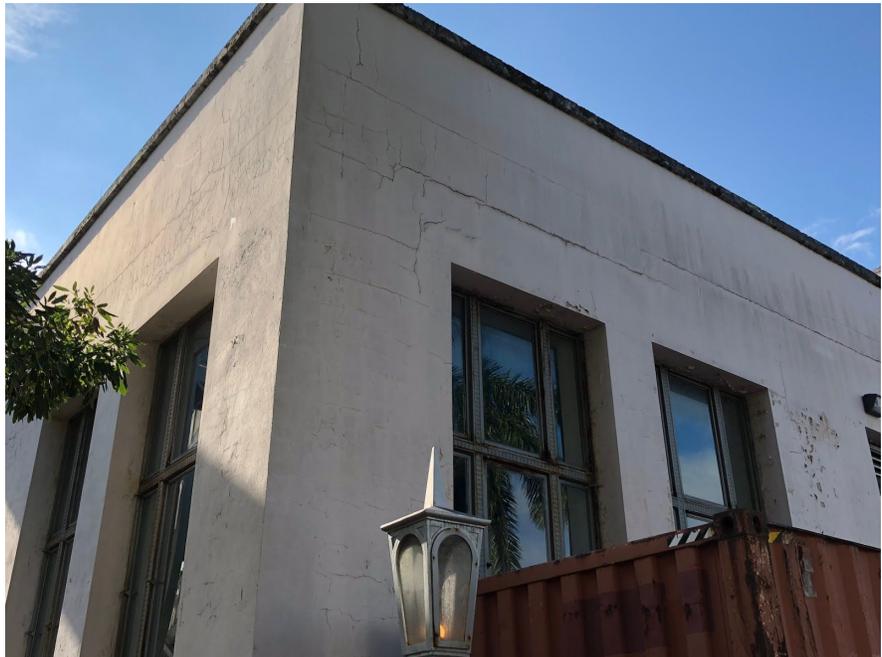
Peeling paint and water intrusion
